PROJECT NO. G-41-2-12a

AJF BOARD PROJECT NO. E-3916

OPERATIONAL SUITABILITY OF THE RADIO EQUIPMENT
IN THE B-29 AIRPLANE*

Serial No. 13 No. of Pages 70 Date 23 February 1945

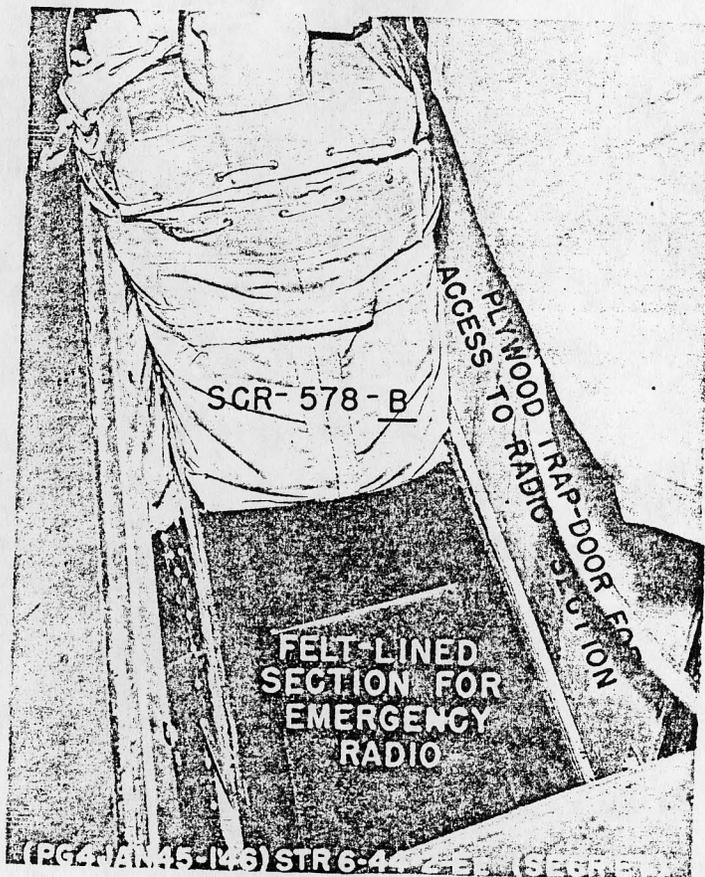
COMPARTMENT FOR STOWING THE LIFE-RAFT
AND DINGHY EMERGENCY RADIO

THE IMPOSSIBILITY OF FITTING THE SCR-578-B INTO THE RADIO SECTION OF THIS COMPARTMENT IS ILLUSTRATED. THIS PICTURE IS USED TO SHOW THE COMPARATIVE DIMENSIONS. ACTUALLY THE COMPARTMENT IS DESIGNED FOR STOWING THE EMERGENCY RADIO FROM INSIDE THE BOMB BAY.

- (1) The stowage compartment for this set be modified to fit the SCR-578-B. (See Figs. 30, 31 and 32)
 - (2) A more reliable method of bonding the felt padding to the walls of the stowage compartment be utilized. (See Fig. 30)

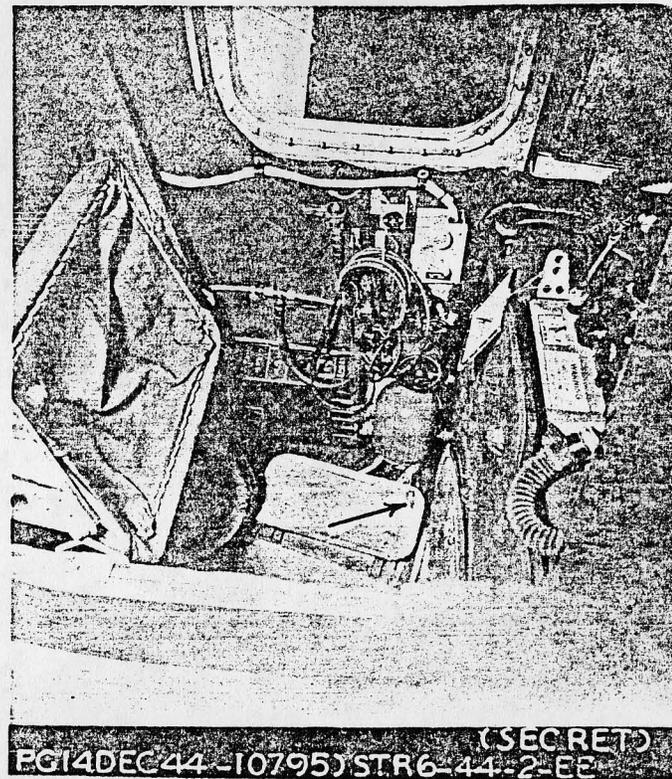
TAIL GUNNER'S COMPARTMENT

The foot button switch for the tail gunner was very difficult to reach because of the "walk-around" oxygen bottle which is located just above the switch. (See Fig. 37) Moving this switch about three inches toward the center line of the airplane would allow the tail gunner to make the best use of this installation. The foot button microphone switches for the side gunners are a big improvement over the cord switches but are still awkward to operate when using the gun sights. The most convenient installation would be a switch on the gun sight. The microphone switch on the top gun sight should be labeled to avoid confusion with other controls on the gun sight.

THE MICROPHONE SWITCH IS DIFFICULT TO REACH
BECAUSE OF THE LOCATION OF THE PORTABLE
OXYGEN BOTTLE

- (1) The tail gunner's foot button microphone switch be made more accessible. (See Fig. 37)
- (2) The bombardier's jack-box be relocated on the left-hand side of the compartment to make it more accessible and eliminate the confusion of cords. (See Fig. 13)
- (3) All foot button microphone switches be modified to prevent "freezing-up" at the low temperatures encountered on high altitude missions.
- (4) The hook for stowing the radio operator's headphones be located clear of the path of the exit hatch to pre-

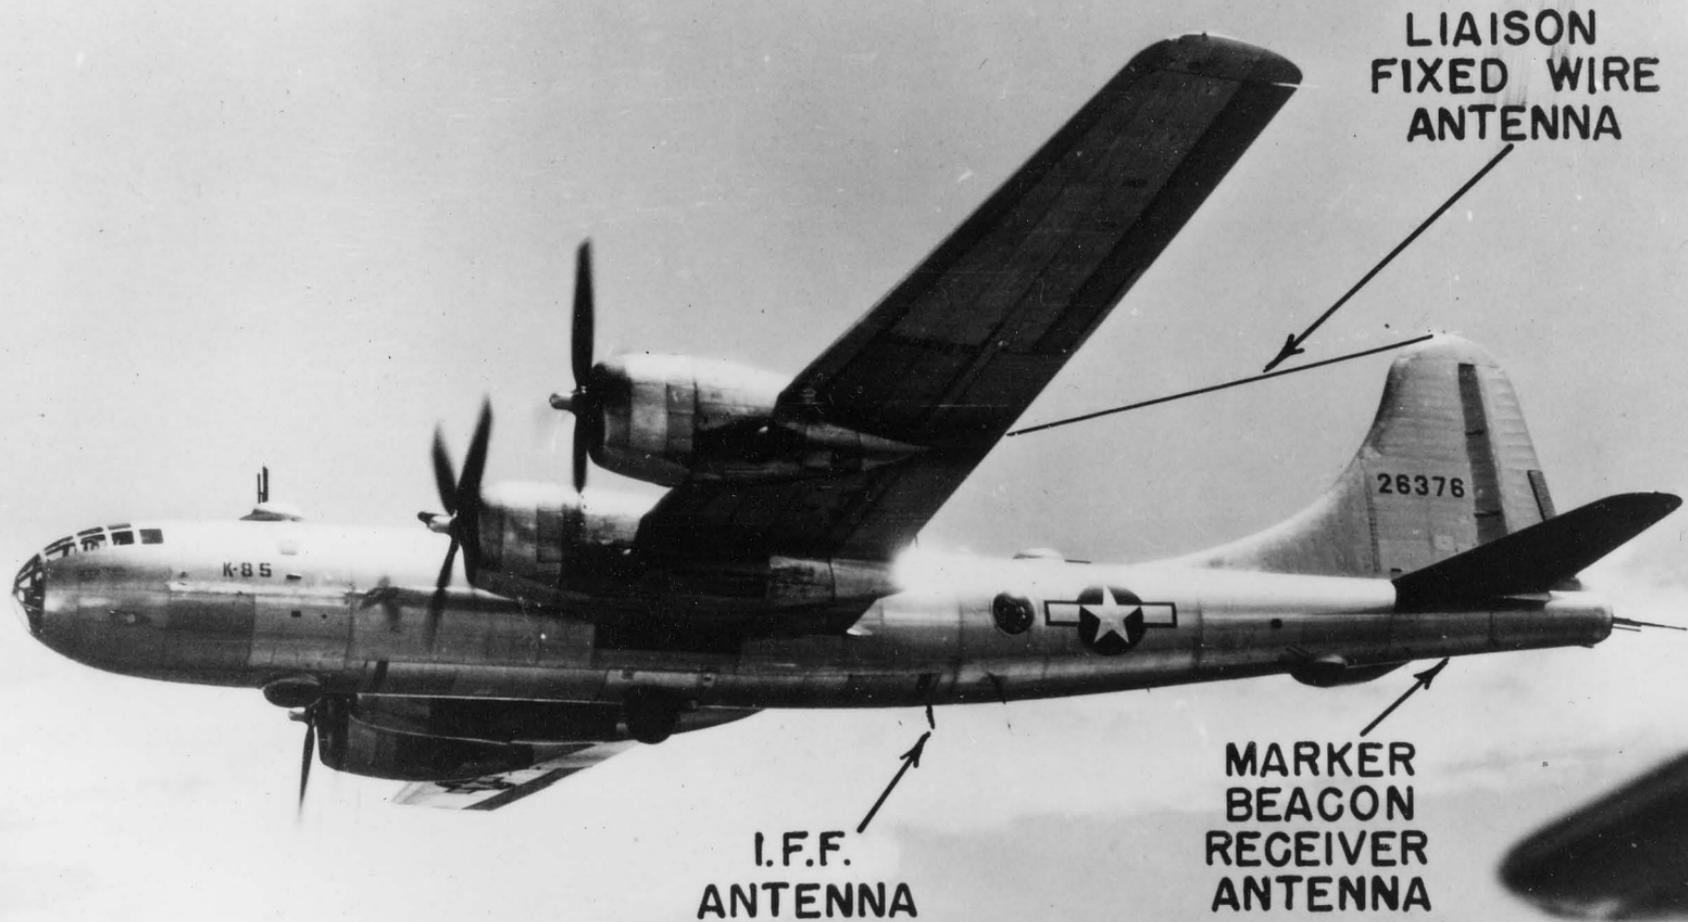
**BLIND LANDING
EQUIPMENT
ANTENNA**

**FEED THROUGH
INSULATORS
FOR COMMAND
AND LIAISON
ANTENNAS**

LIAISON
FIXED WIRE
ANTENNA

I.F.F.
ANTENNA

MARKER
BEACON
RECEIVER
ANTENNA

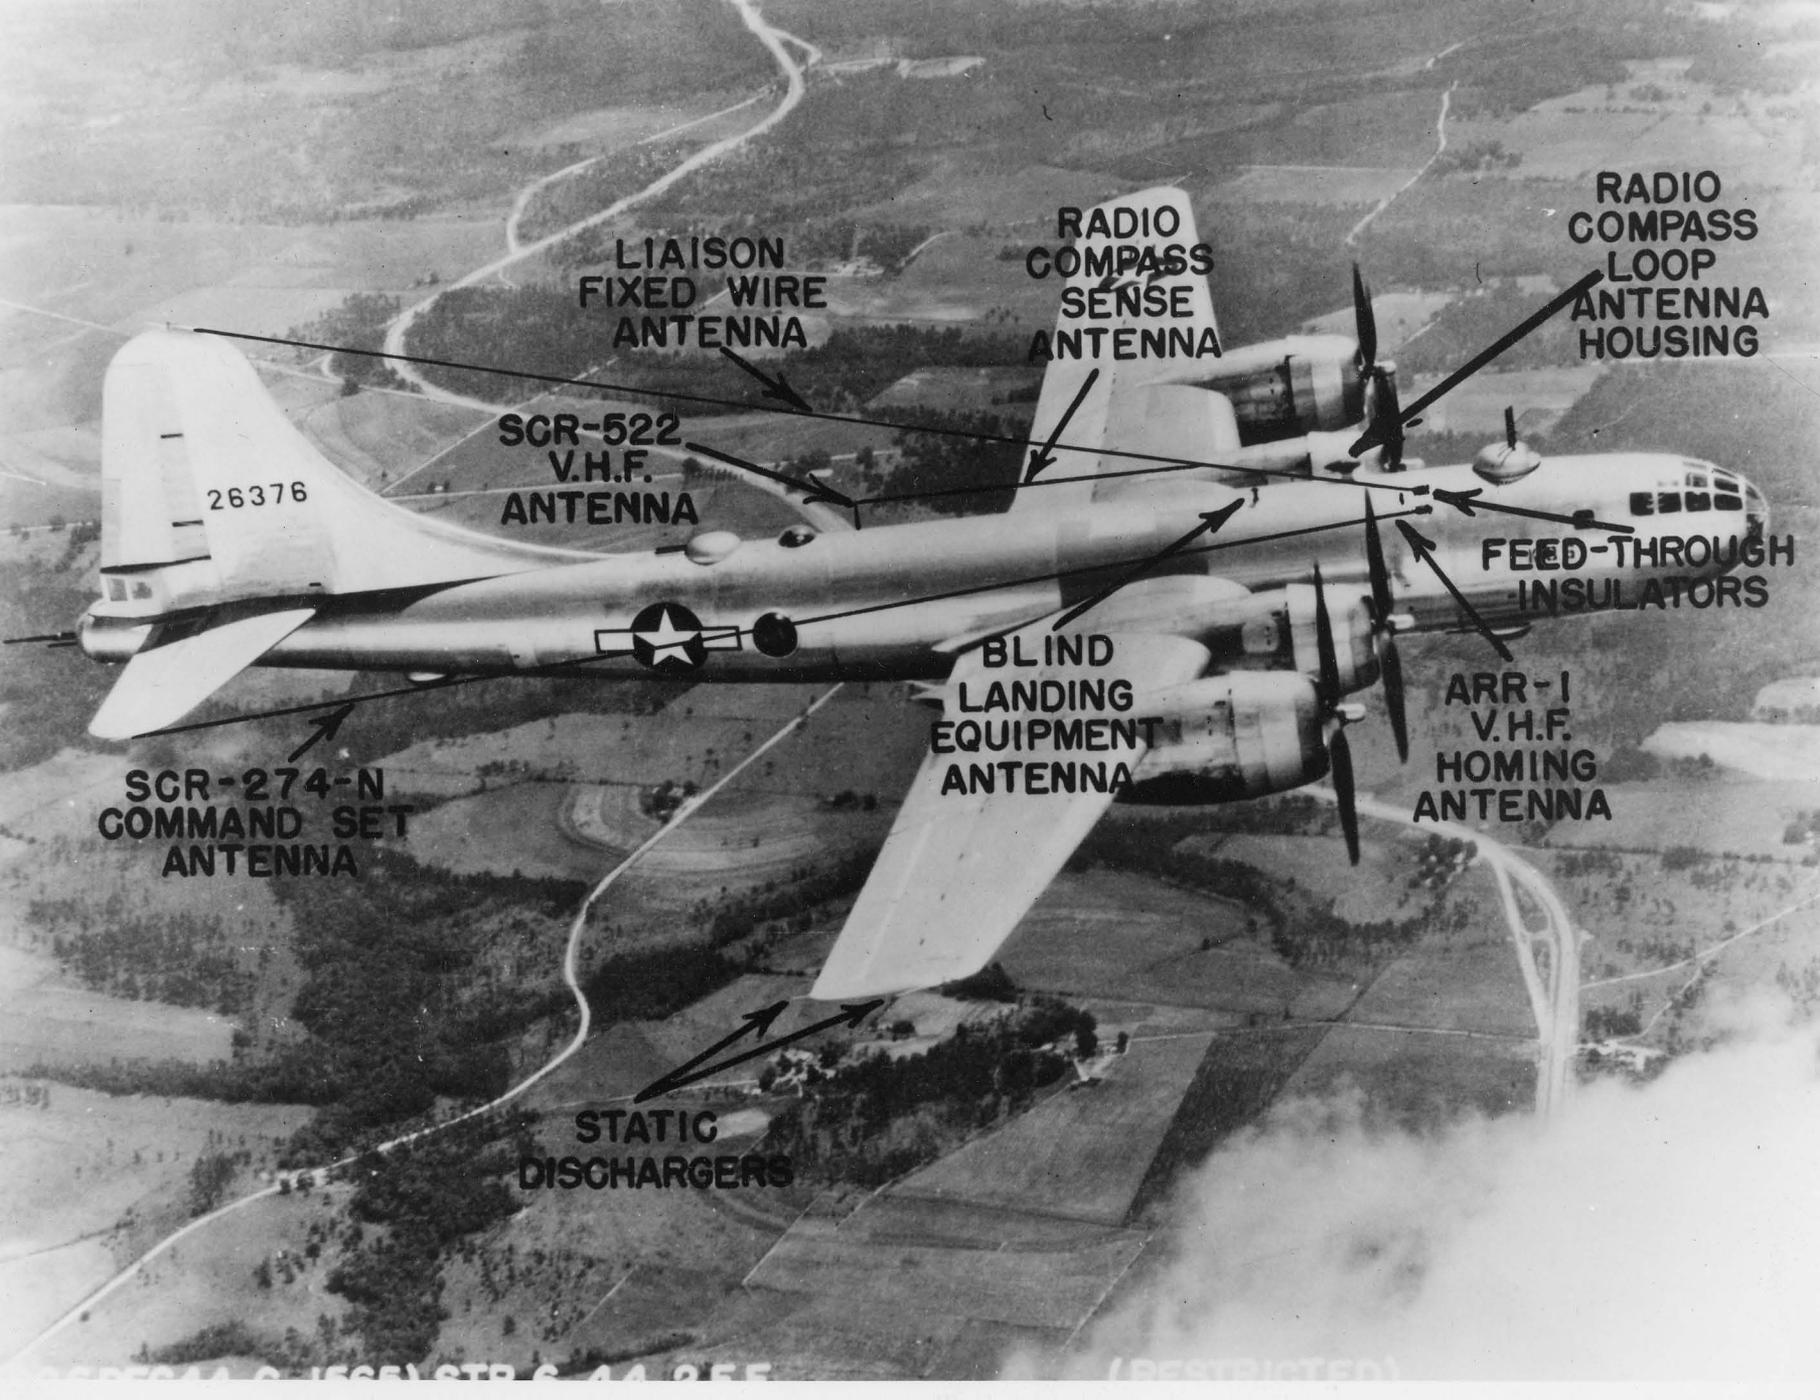
LIAISON
FIXED WIRE
ANTENNA

RADIO
COMPASS
SENSE
ANTENNA
